City of Daytona Beach Shores

"Life is Better Here"

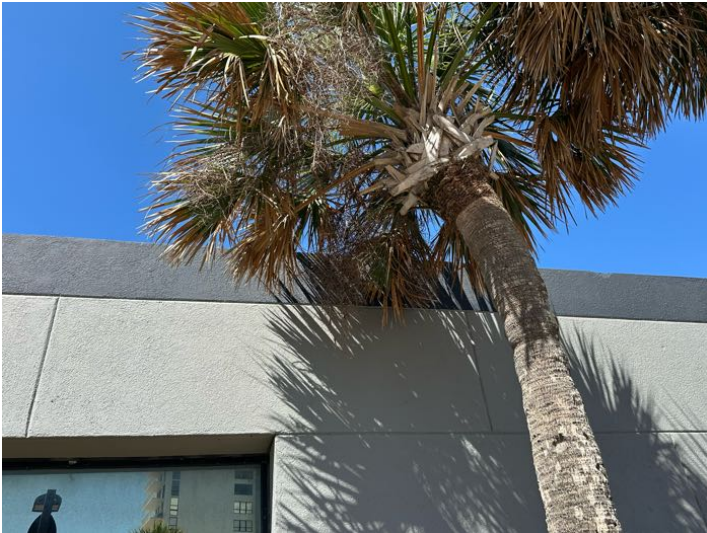
Palm fronds need to be trimmed back

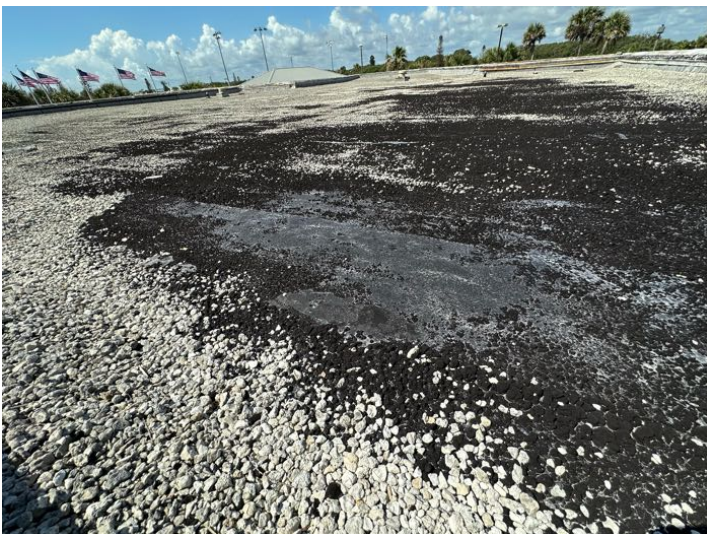
Large area of missing gravel on the roof

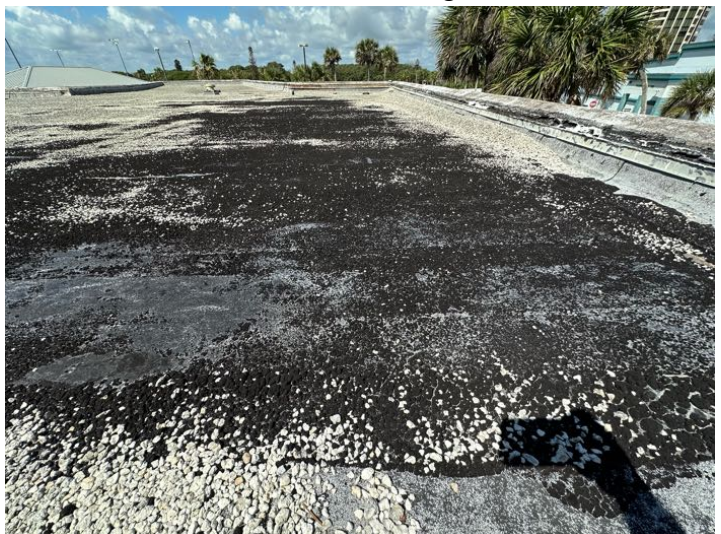
Large area of missing gravel on the roof

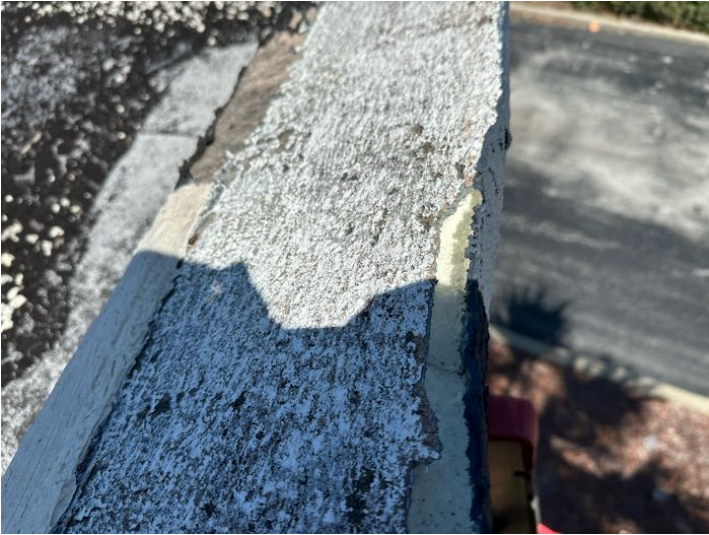
Damage to parapet wall cap

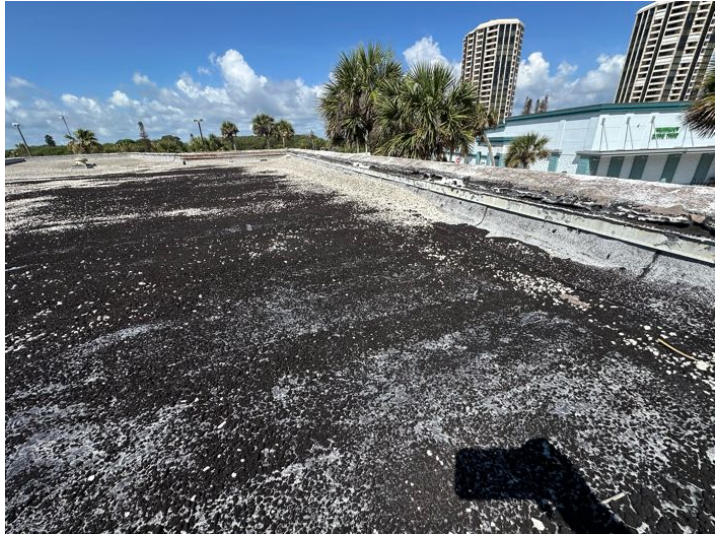
Large area of missing gravel on the roof

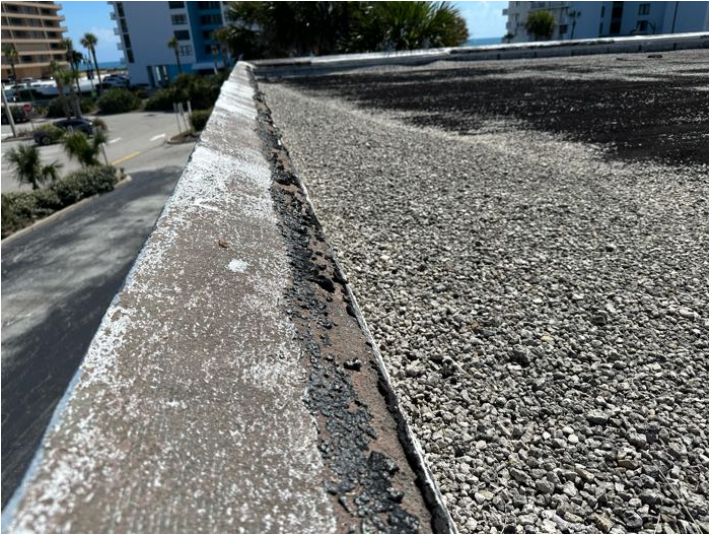
Damage to parapet wall cap

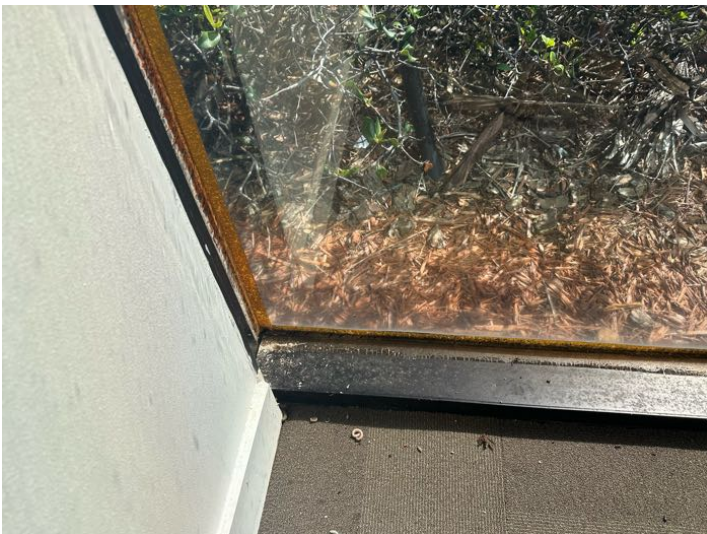
Window seal appears to be failing

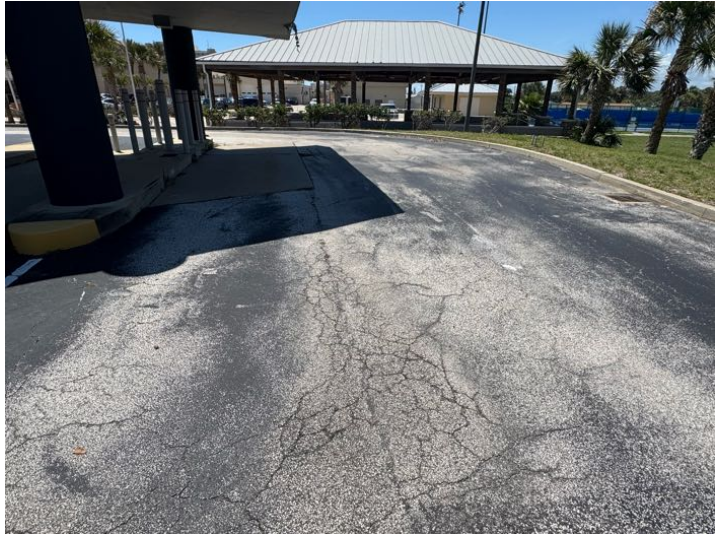
Weathered/worn area of parking lot

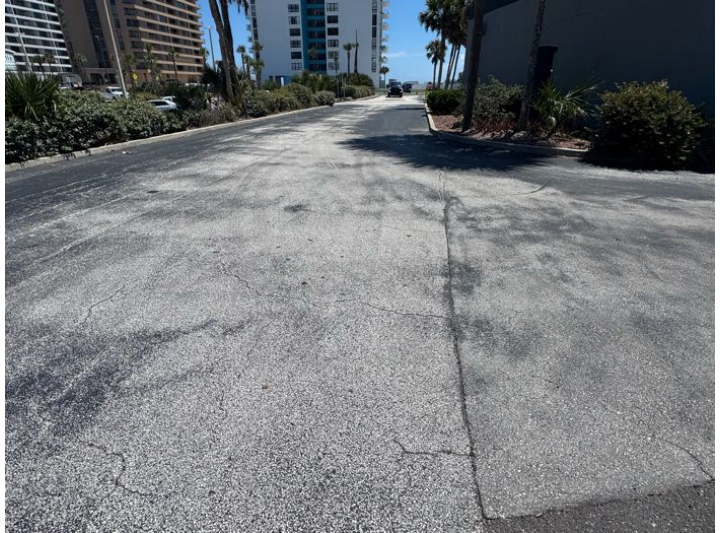
Worn area of parking lot

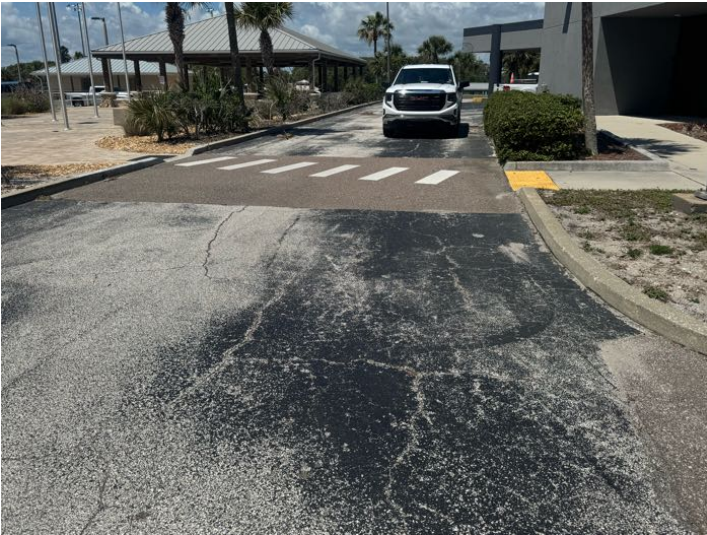
Worn area of the parking lot

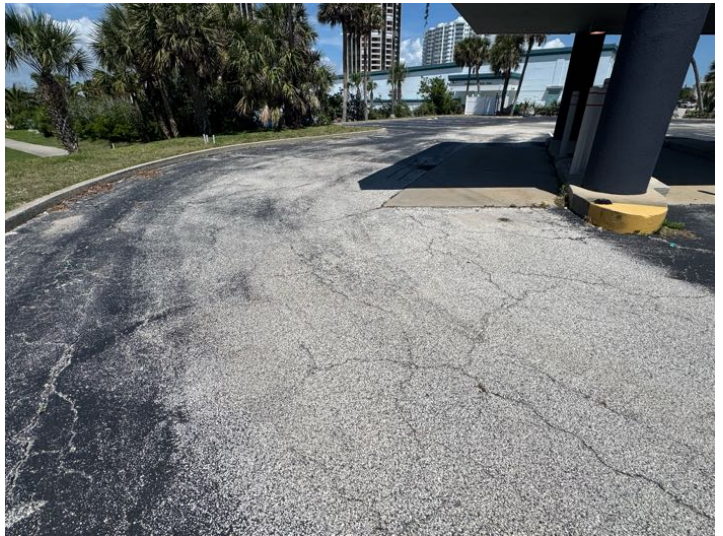
Worn area of parking lot

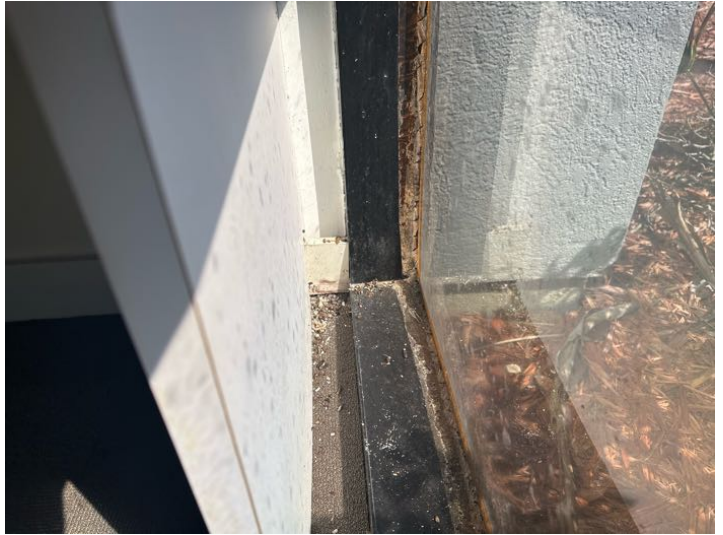
Window seal appears to be failing

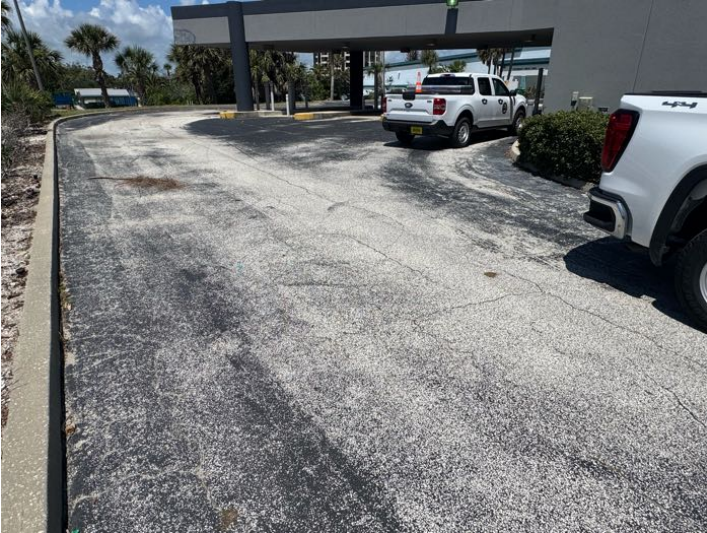
Worn area of the parking lot

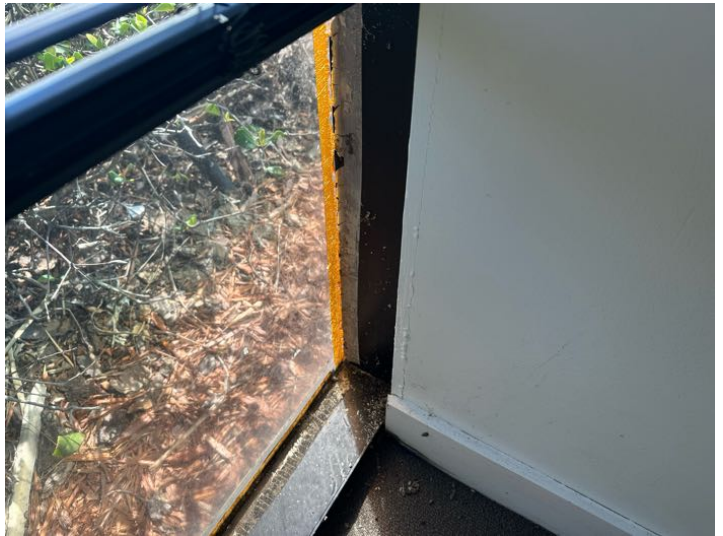
Window seal appears to be failing

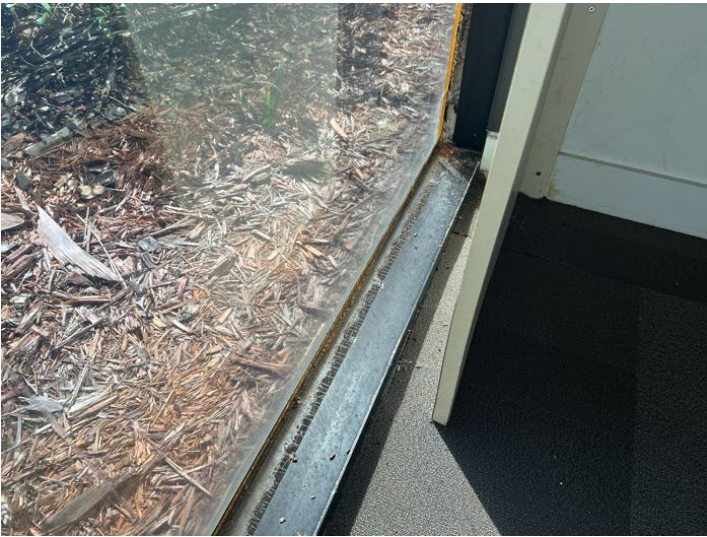
Window seal appears to be failing

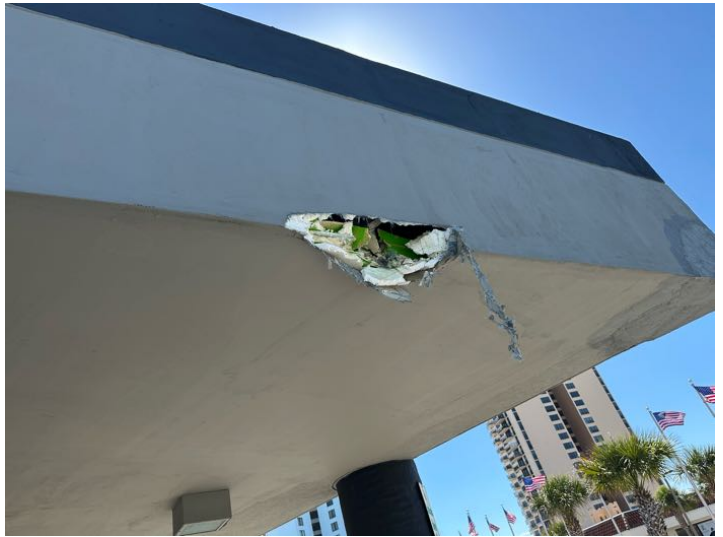
Damage to exterior siding at the drive-through

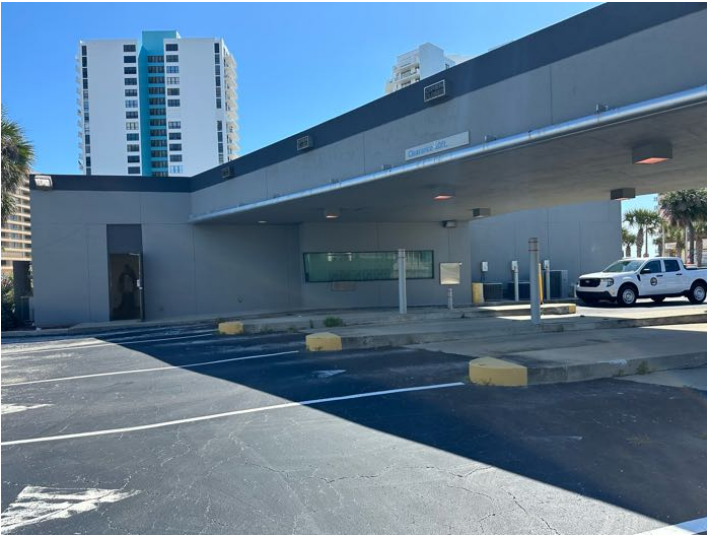
Rear of the building

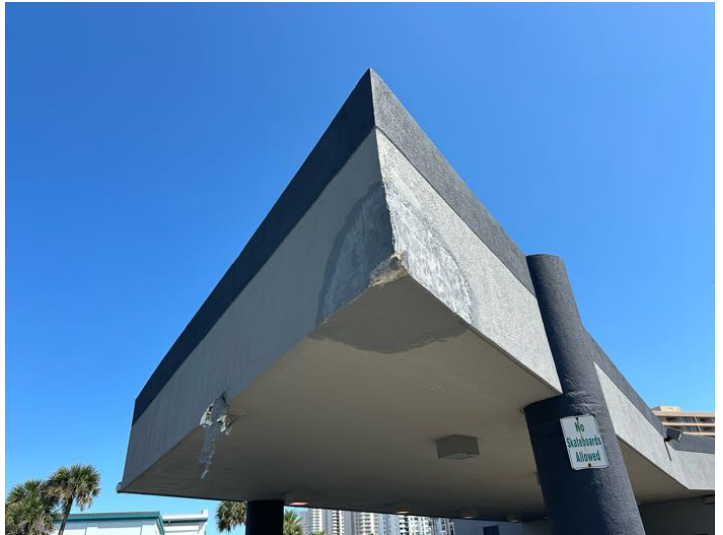
Damage to exterior siding at the drive-through

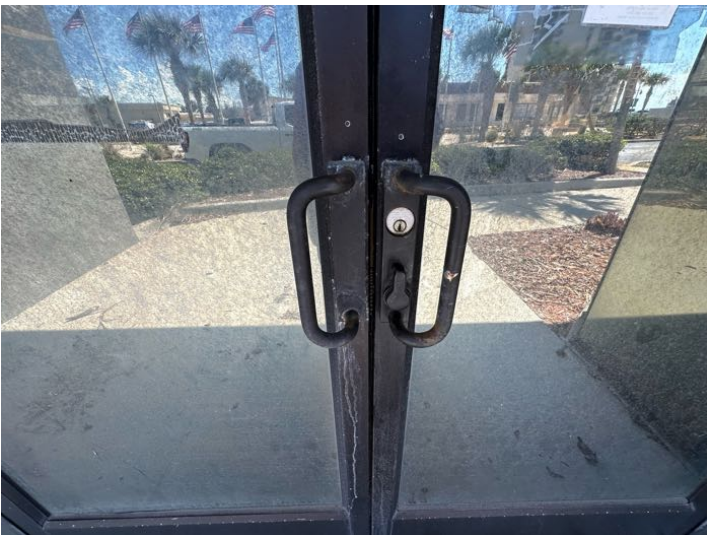
Rust on metal components

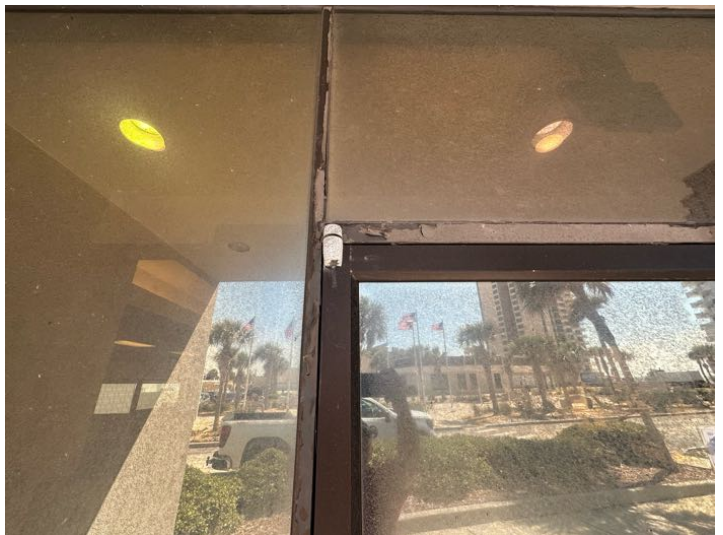
Apparent damage on window seals

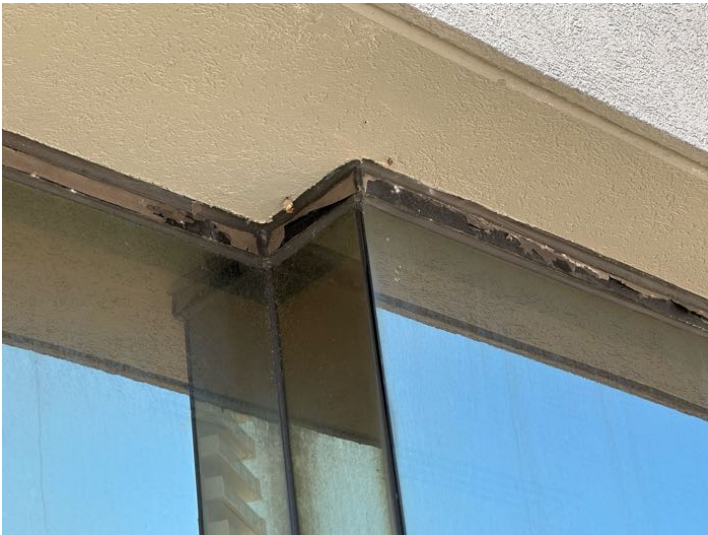
Apparent damage on window seals

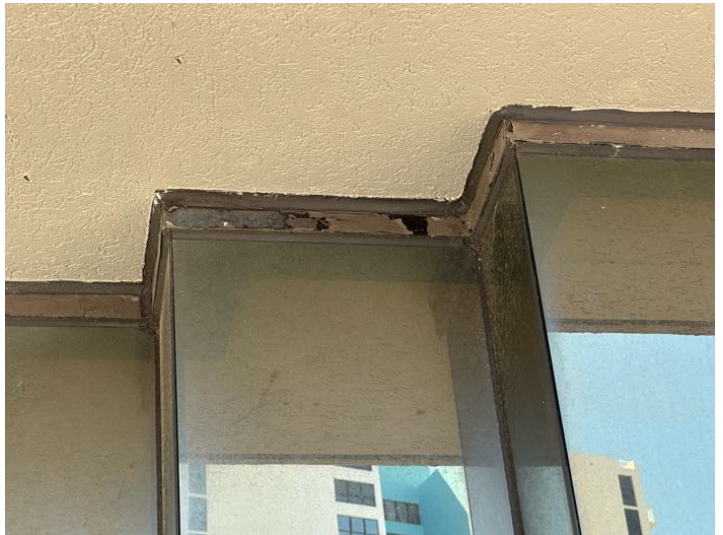
Apparent damage on window seals

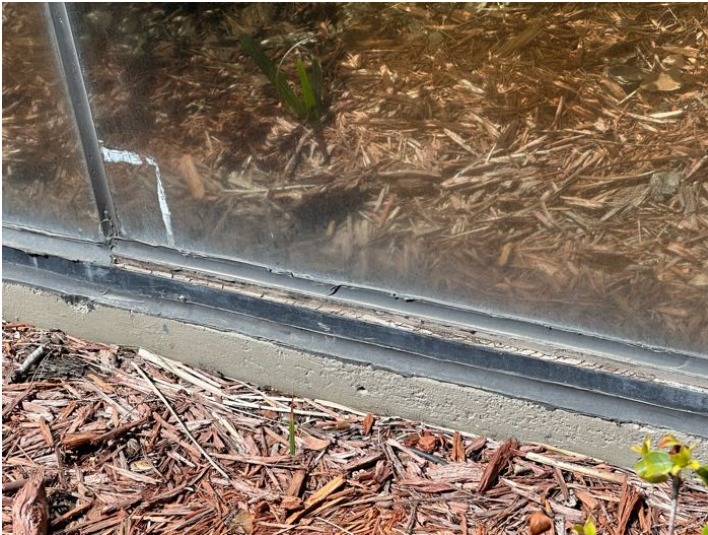
Apparent damage on window seals

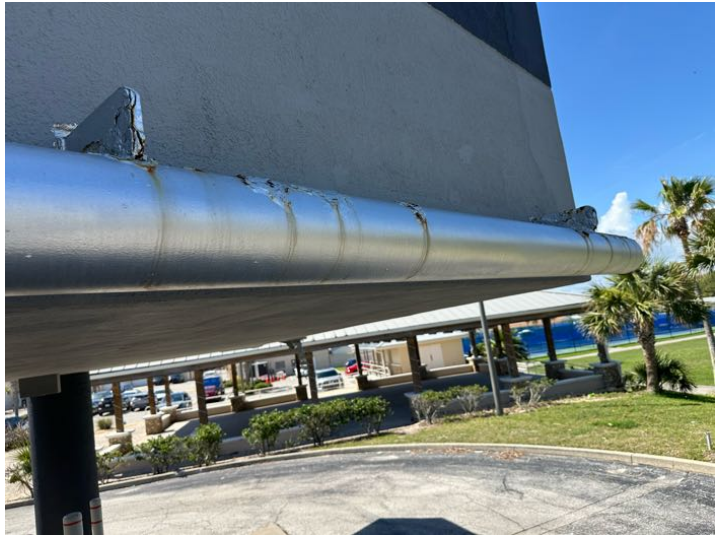
Rust on exterior metal component

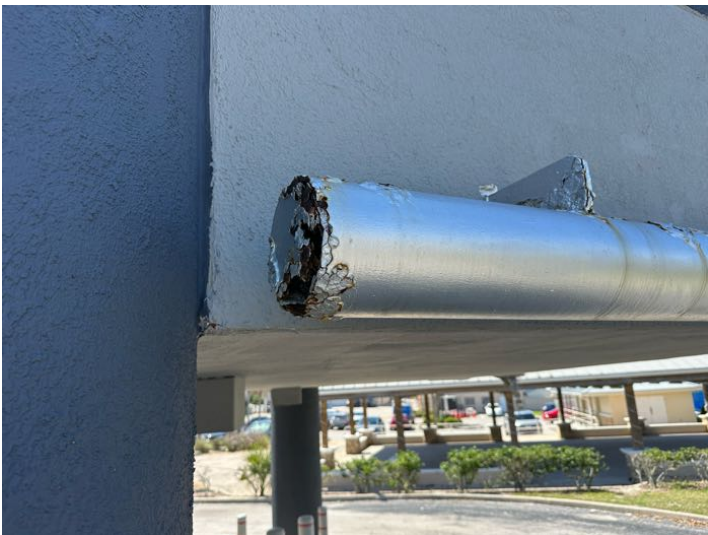
Rust on exterior metal component

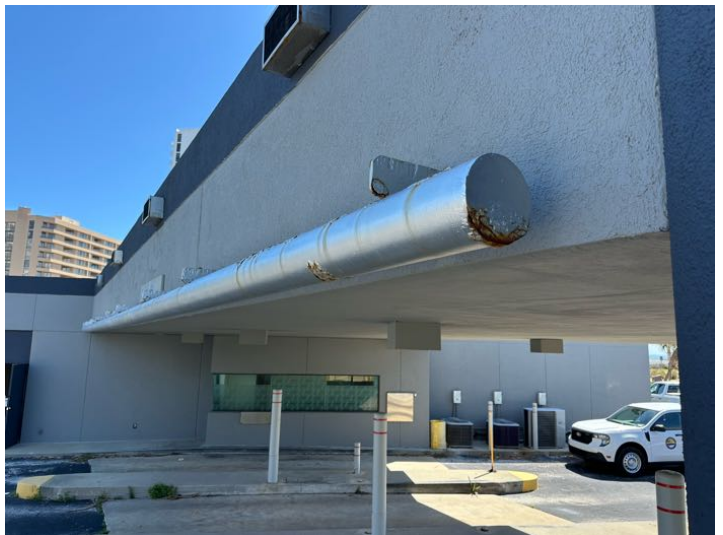
Rust on exterior metal component

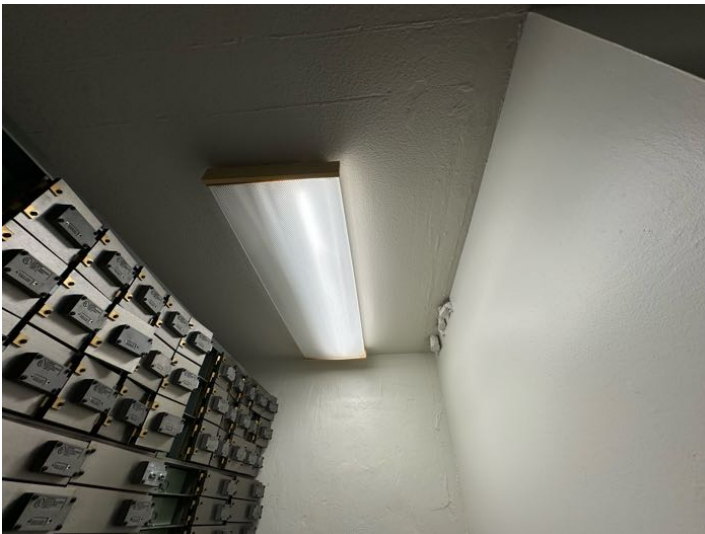
Light bulb did not operate

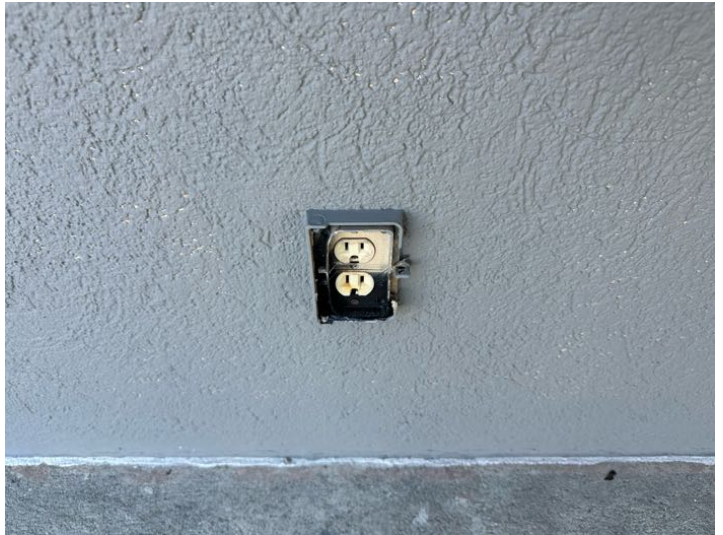
Missing cover on exterior electrical outlet

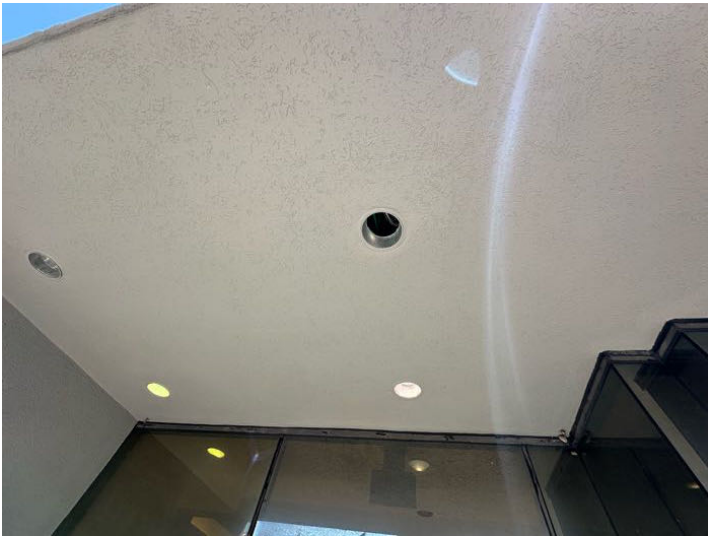
Missing light fixture

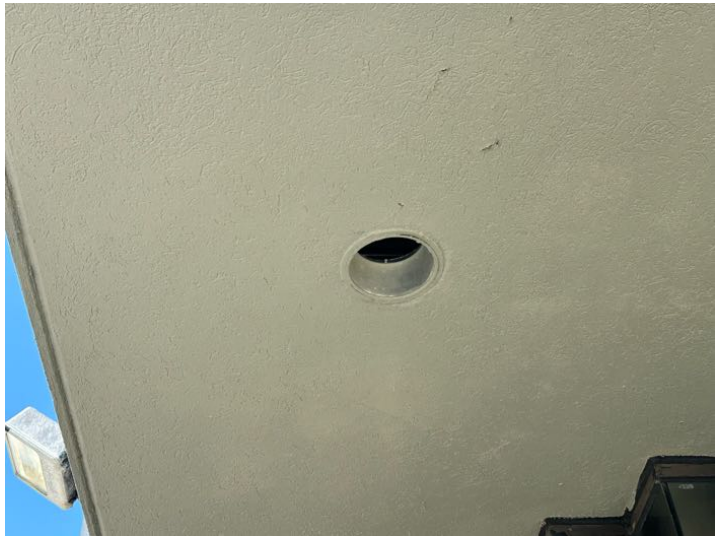
Missing light fixture

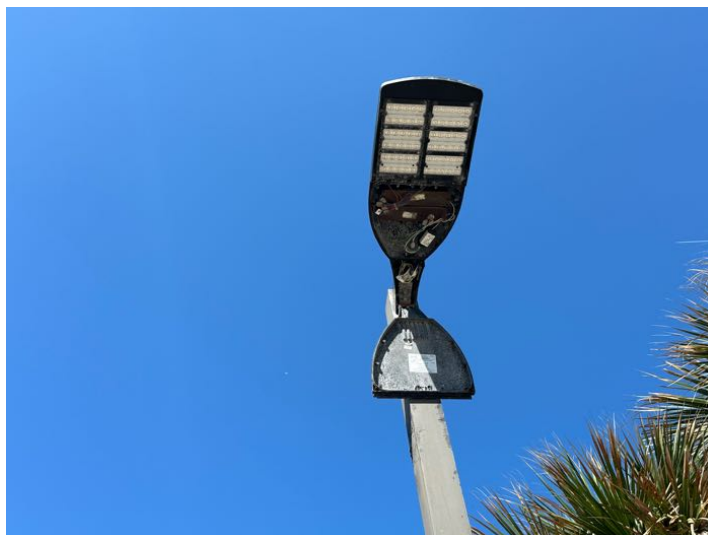
Damaged parking lot light fixture

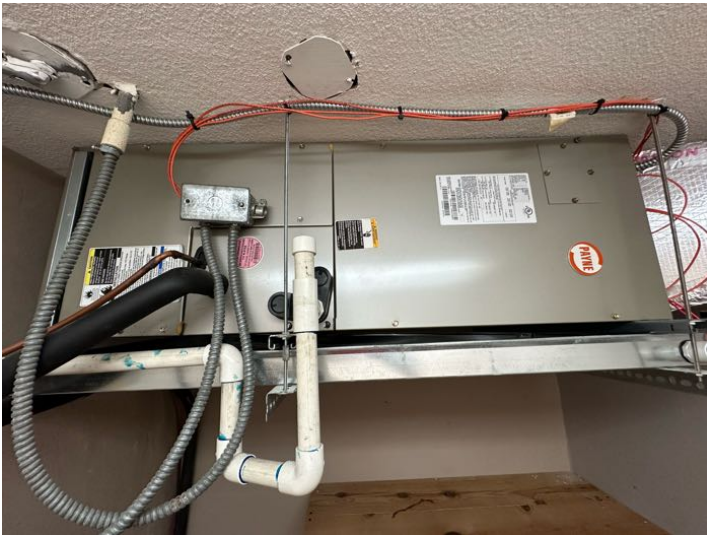
1.3. The mini-split air conditioning system in the utility room displayed an error code and would not operate when tested. Further investigation will be needed to determine the exact cause and proper course of repair. Contact a licensed air conditioning contractor to review and repair as needed.

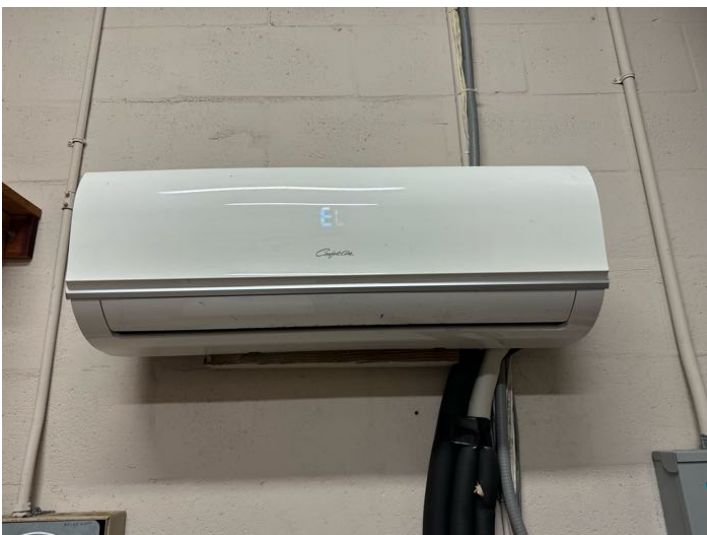
Error code displayed on the mini-split air conditioner unit

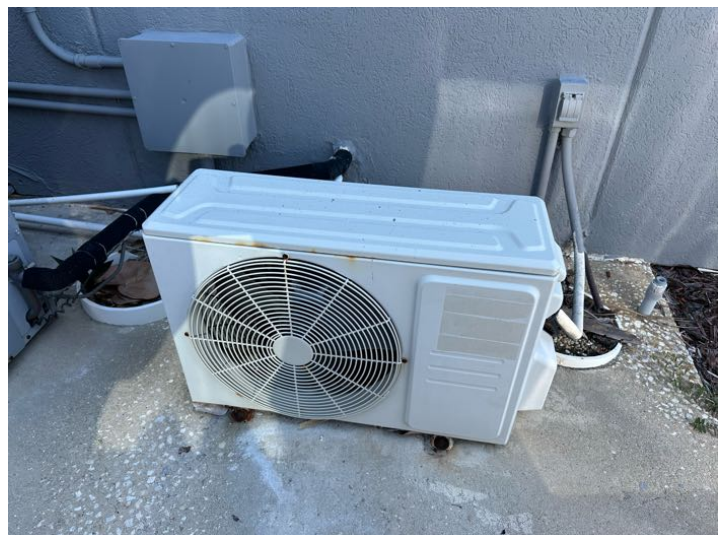
Mini-split air conditioner compressor unit

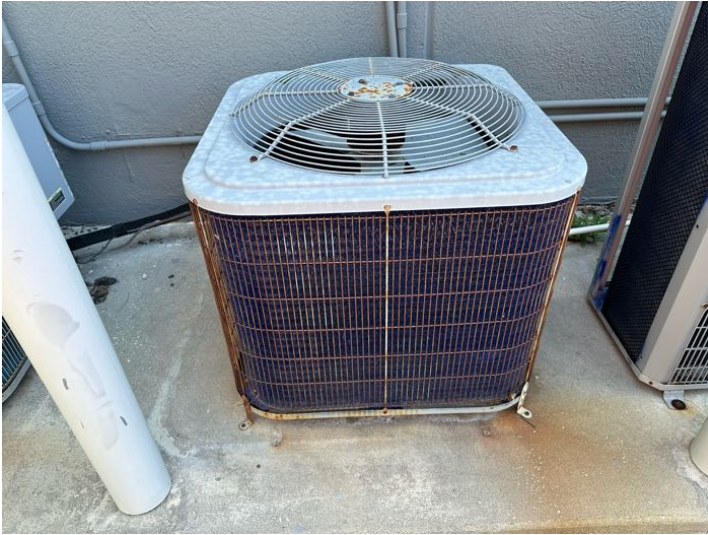
Rusted air-conditioning compressor unit

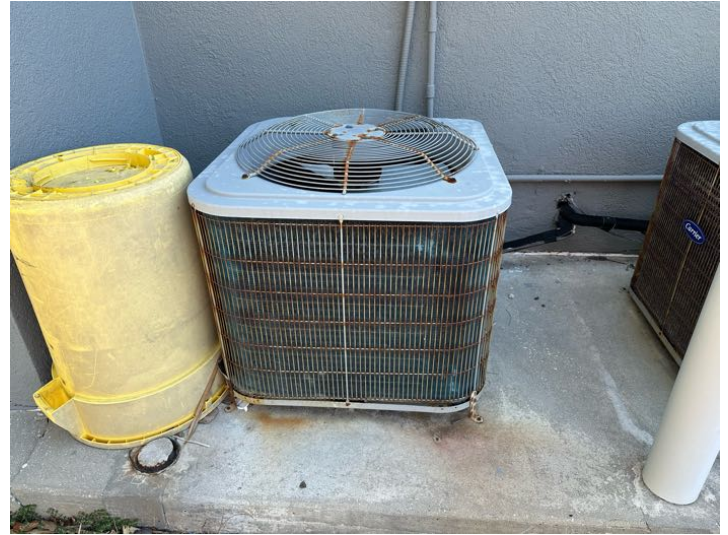
Rusted air-conditioning compressor unit

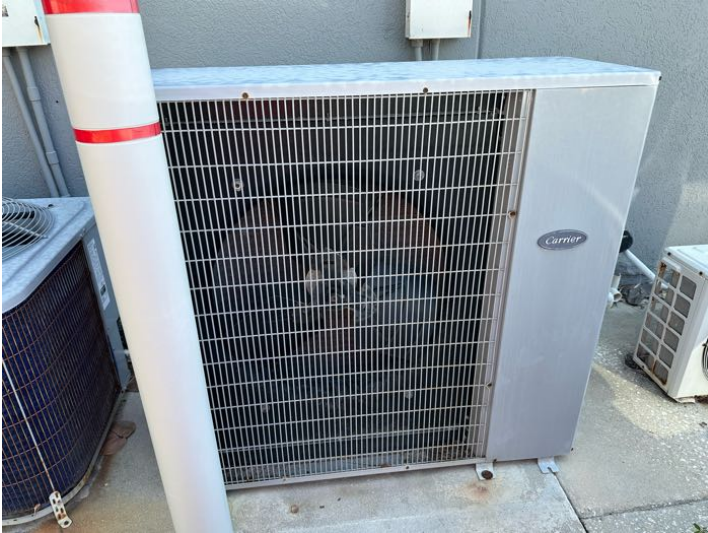
Rusted air-conditioning compressor unit

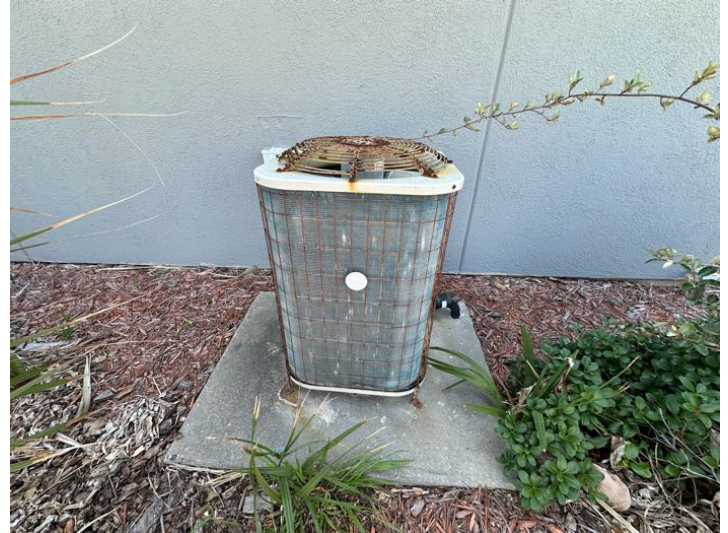
Rusted air conditioning compressor unit

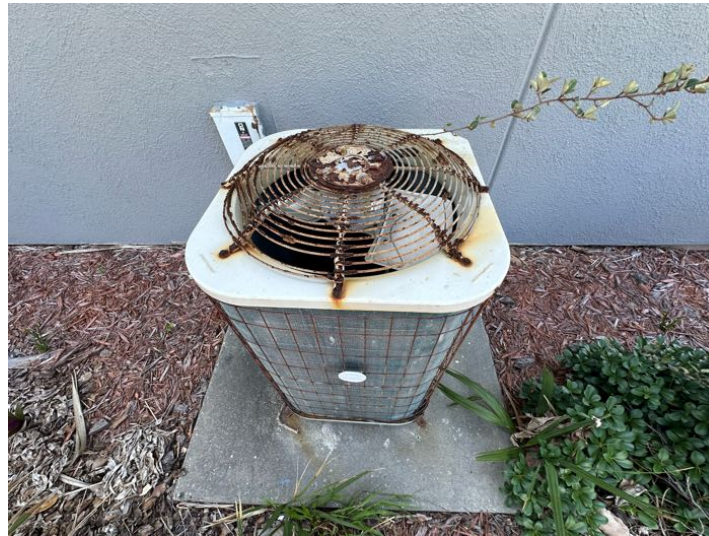
Rusted air conditioning compressor unit

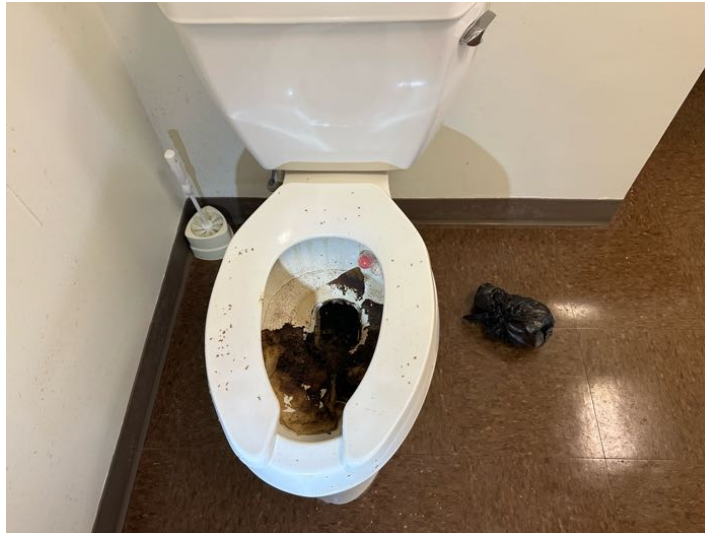
Toilet not tested (no water)

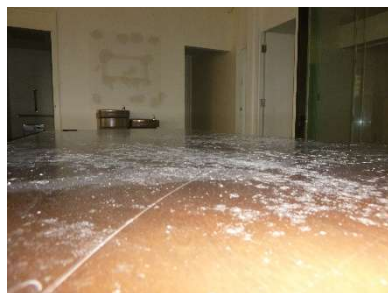
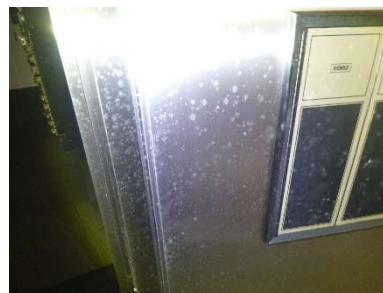
Project: Daytona Beach Shores - Former bank of America Mold Remediation

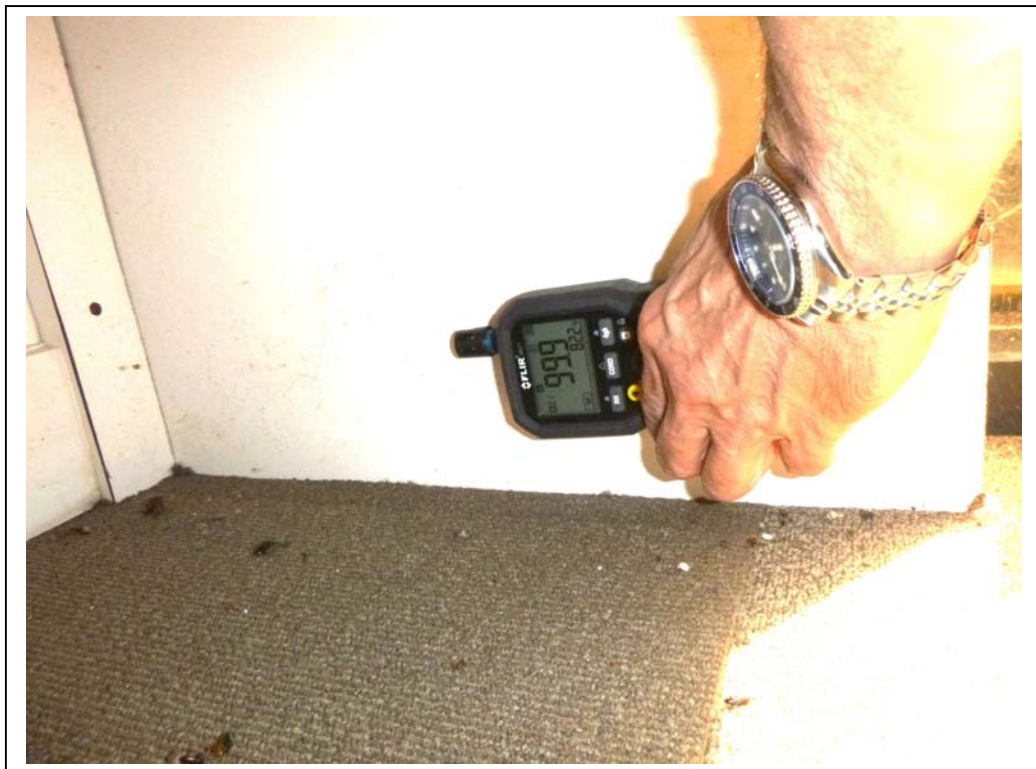
Photo #8; Private Room #1 - Lower Desk Panel (Wet) Surface Moisture Measurement View

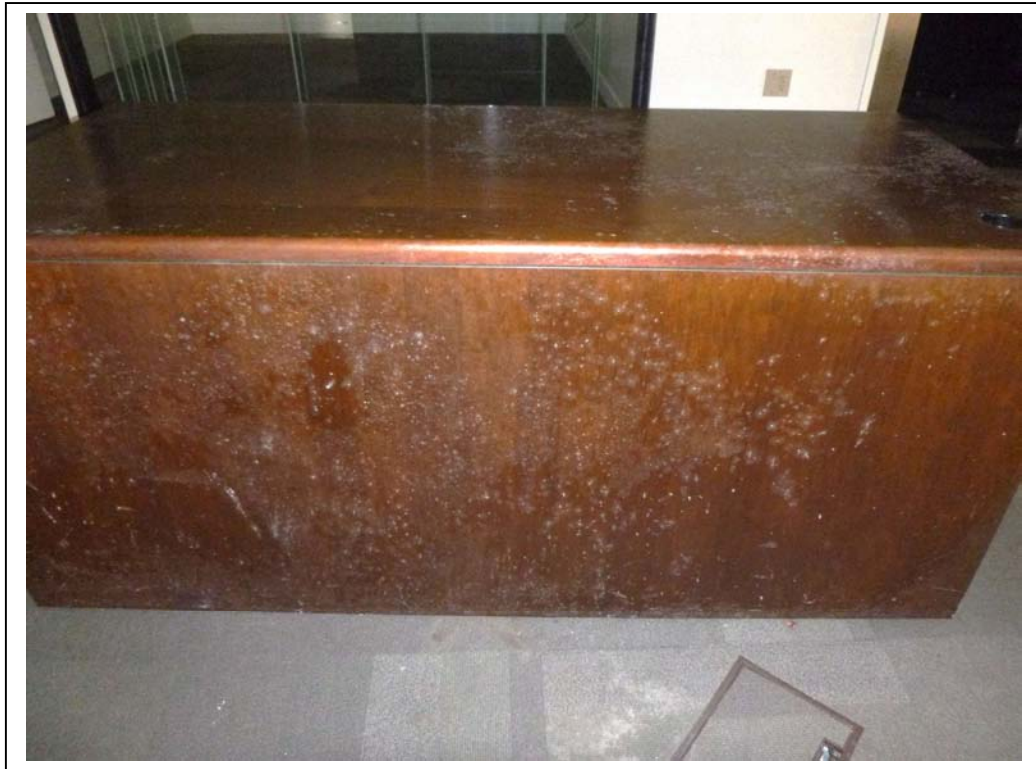
Photo #9; Representative Moldy Desk In Main Lobby View

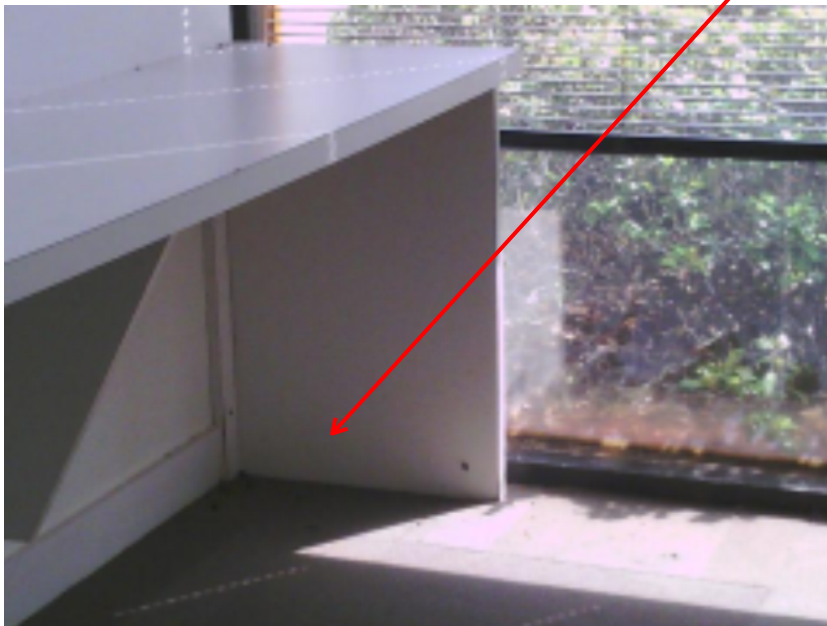
6/4/2026 11:25:55 AM

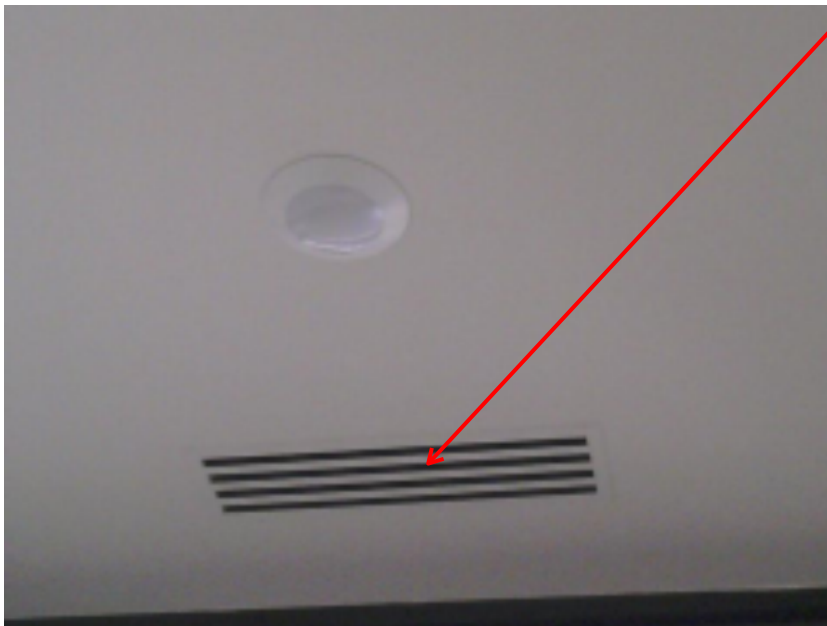
6/4/2026 11:26:26 AM

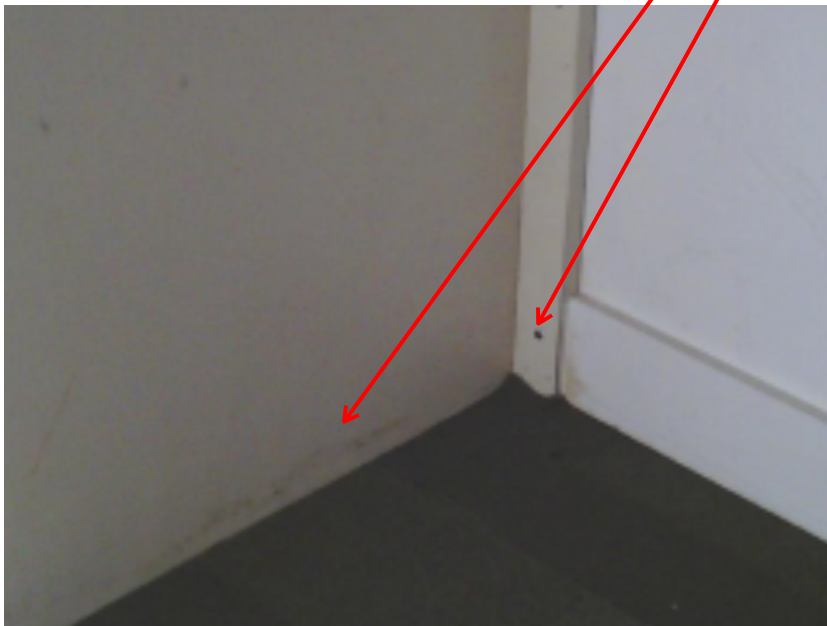
6/4/2026 11:27:04 AM

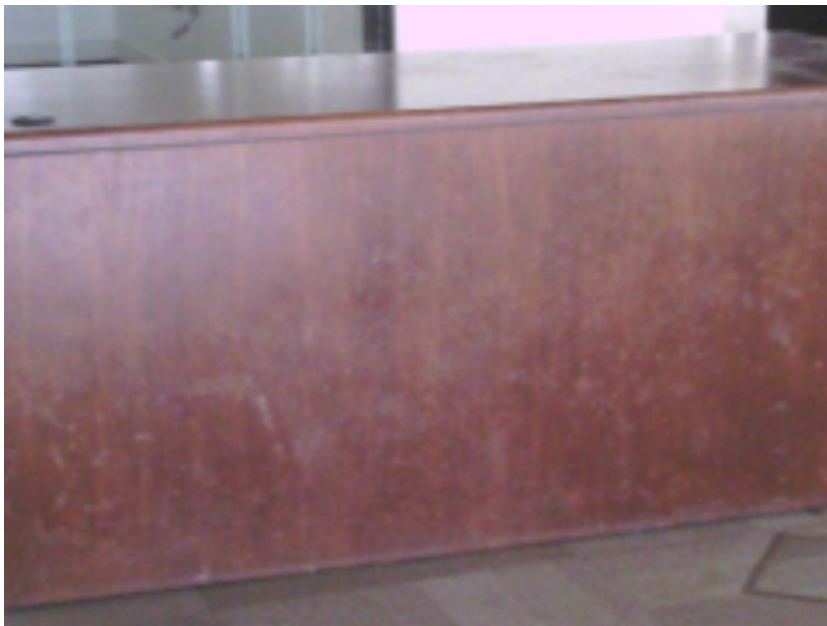
6/4/2026 11:34:16 AM
